Indiana Department of Environmental Management
Office of Water Quality
Wetlands Section

PUBLIC NOTICE

| 5. Project Description: | The applicant is applying for Section 401 WQC to impact a total of 543 linear feet of stream along numerous areas of Crooked Creek. The proposed activity is associated with repairs to failing areas of a previously approved 2000 linear foot stabilization project (IDEM Project Number 2002-658-43-JWR-A). Specific repairs will consist of placing stone toe protection along a total of 247 linear feet of bank, improving existing stone cribs and lifts in numerous areas along 236 linear feet of bank and placing riffle-grade control along 60 linear feet of the channel. For additional information, please visit the webpage at http://www.in.gov/idem/6396.htm . | | |

CROOKED CREEK STREAM BANK RESTORATION

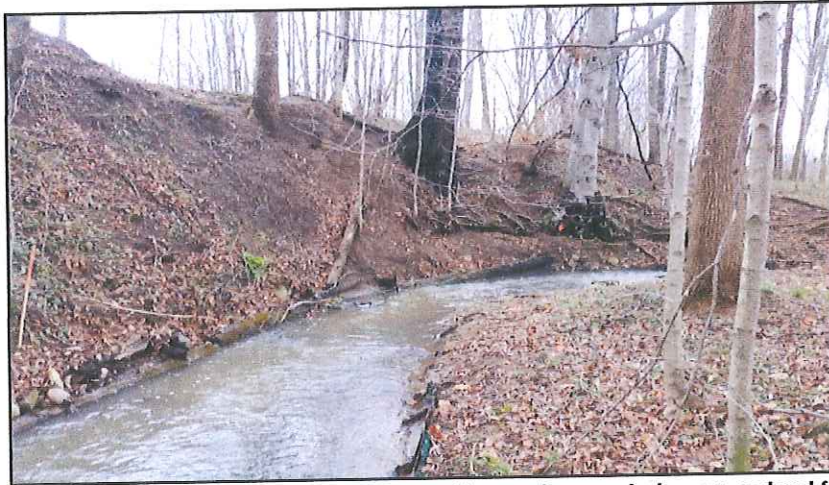
Figure 1 - Station 20+00 looking upstream. Top log missing and bottom logs nearly decomposed and falling apart. High stream flow is beginning to erode the soil behind the logs.

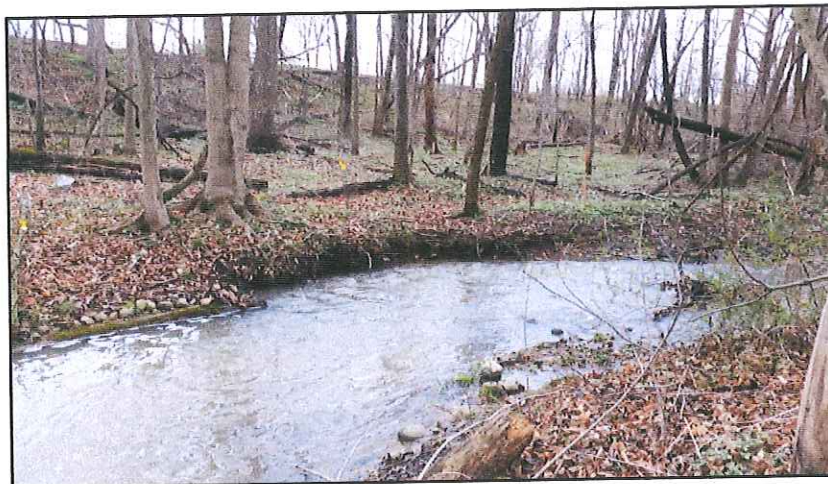
Figure 2 - Station 18+00 looking upstream. Log Crib Wall now missing except for a small log and some stone. Sandy loam soil with high stream flow velocity will continue to erode the banks, even with the root mass from the trees.

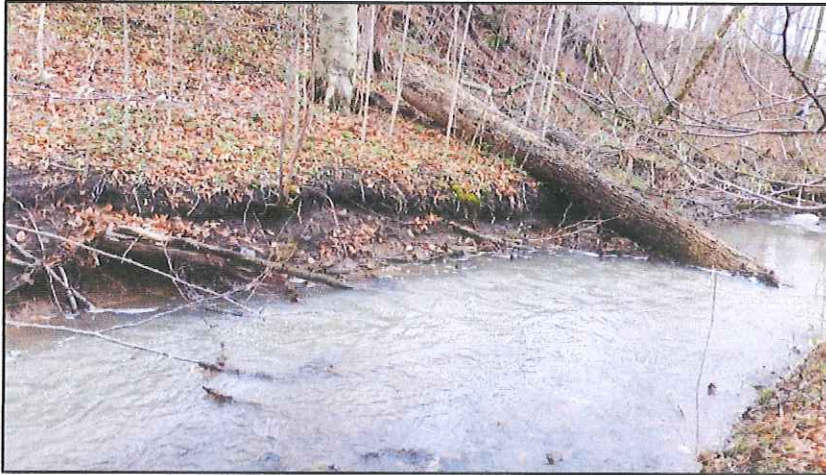
Figure 3 - Station 15+00 looking downstream. Log Crib Wall has decomposed or washed away. Sandy loam banks are beginning to erode with existing protection.

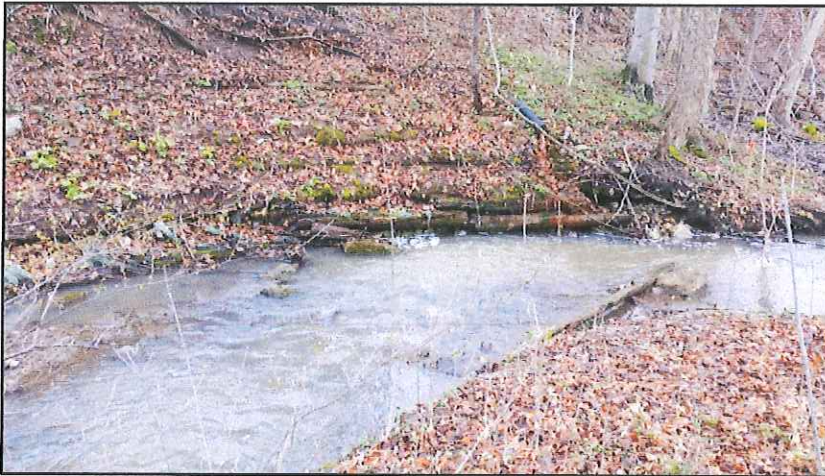
Figure 4 - Station 17+00 Log Crib Wall with encapsulated lifts. Lots missing to left of picture and remaining logs unstable and have limited life left. When the logs break loose the entire bank will slide into the stream.

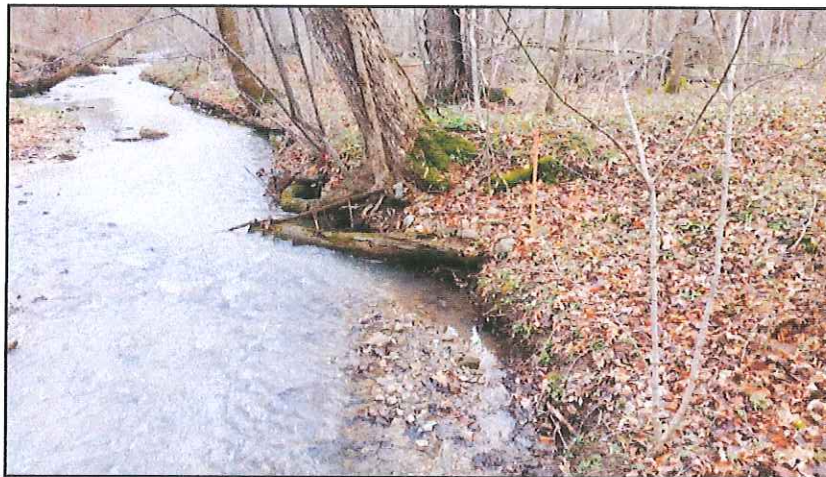
Figure 5 - Note steel rods remaining after log crib decomposed and fell apart. The steel rods are numerous throughout the stream bank.

8. All disturbed areas within the project limits, including access and staging areas will be repaired to preconstruction conditions.
9. Previously failed bio-engineering practices utilizing logs and re-rod will be removed from the project limits or secured to stream bed if the logs have not deteriorated.
